HATHAWAY POND DAM

PHASE I INSPECTION REPORT
NATIONAL DAM INSPECTION PROGRAM

MICHAEL BAKER, JR., INC.

Hathaway Pond Dam, Susquehanna County, Pennsylvania
NDI No. PA 00050, PennDER No. 58-06
West Branch of Lackawanna River
Inspected 30 October 1980

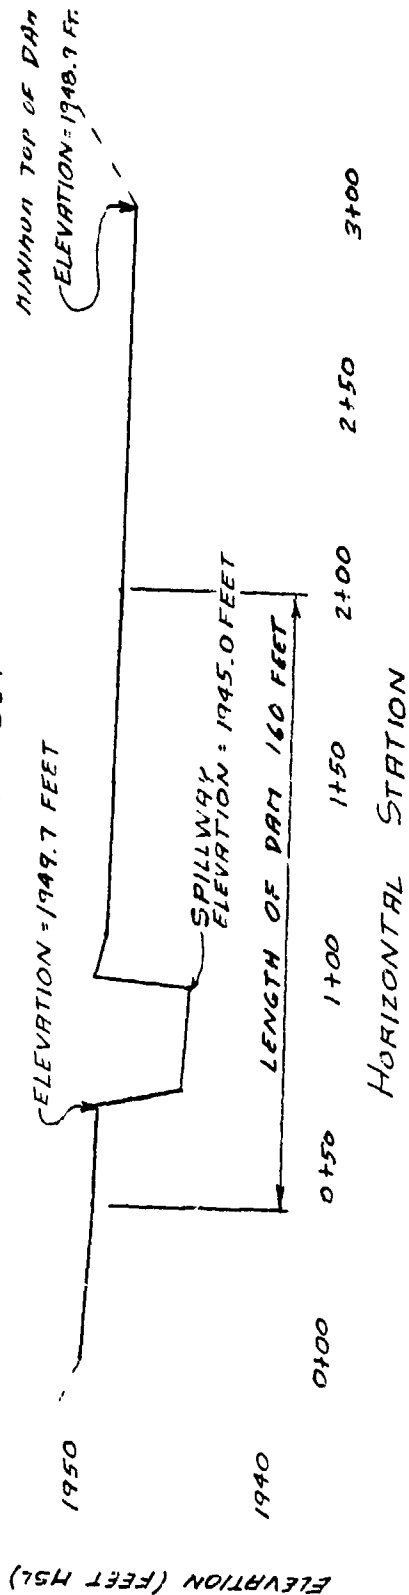
TOP OF DAM PROFILE (LOOKING DOWNSTREAM)

LENGTH OF DAM = 160 FEET
